**Level 1 Geotechnical
Inspection and Testing
Authority Report**

**Stage 7C West, River Valley Estate,
Sunshine North**

Prepared by
Tonkin & Taylor Pty Ltd

Date
January 2023

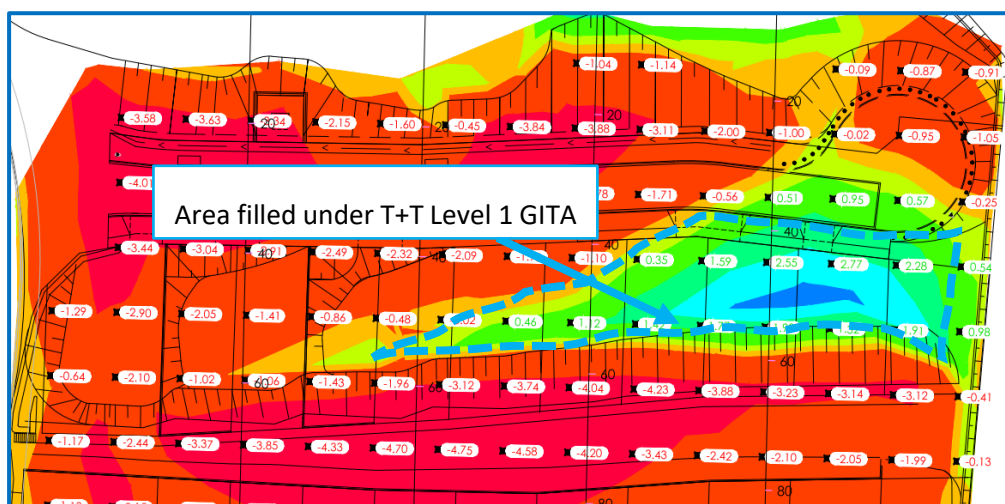
Figure 2: Extract from CJ Arms drawing showing Bulk Earthworks³ fill thickness supervised by T+T

As shown in Figure 2 and in the drawings in Appendix D, fill was placed between Lot 15 and Lot AA.

The fill levels indicated in Figures 2 and 3 are discussed further in Section 4.8: Fill Thickness Analyses.

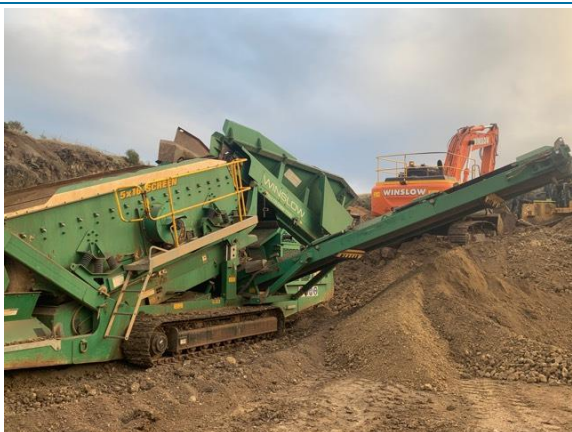
Photo # and Description	Photo # and Description
<p>Photo 1: Screening plant used in Stage 7D</p>

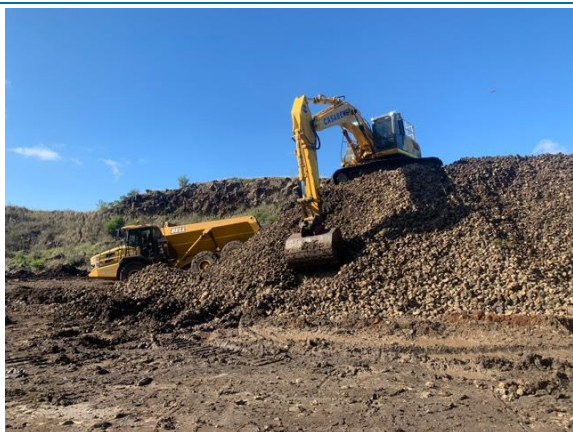
<p>Photo 2: Excavator and Moxy truck – loading screened fill material from Stage 7D</p>

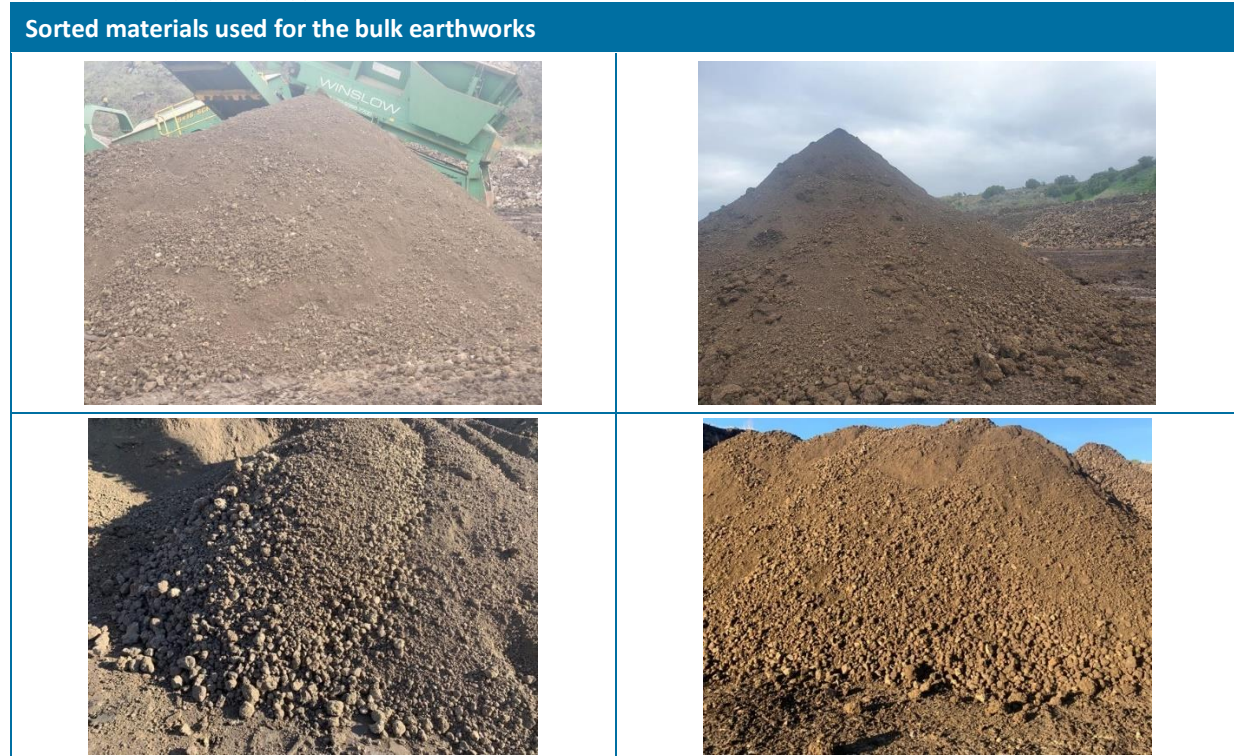
Figure 7 Photographs of typical material used on site

Several photographs of the sieved fill materials used during construction are shown in Figure 7.

The soil is considered as 'Suitable Material' in accordance with Section 4.4 of the AS3798-2007.

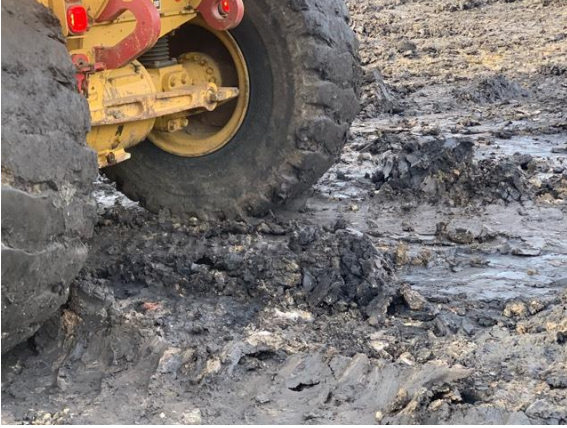
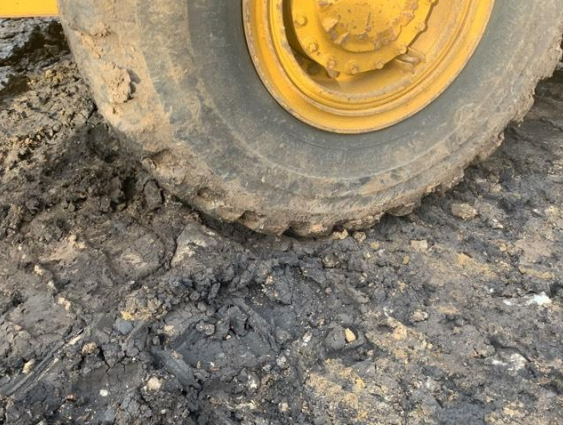
Figure 8 Photographs showing the subgrade proof roll and benching on the upper lots

Photograph number and description	Photograph number and description
Photograph 1: Proof Roll upper Lots	Photograph 2: Proof Roll upper Lots

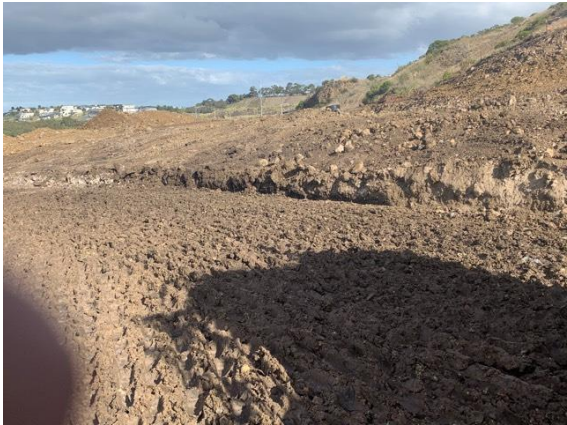
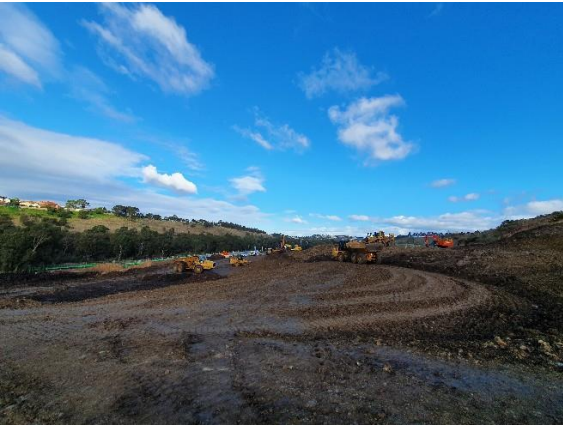
Photograph 3: Benching on upper Lots	Photograph 4: Benching on upper Lots

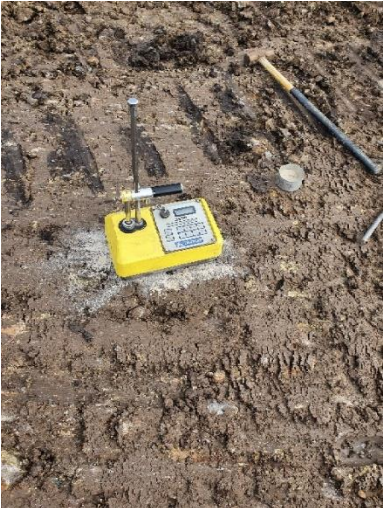
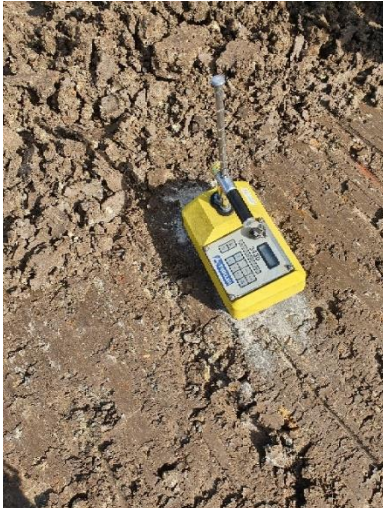
Figure 10: Field Density Testing

A total of thirty-five (35) tests were performed during the filling process. All tests returned a passing density and moisture test result.

Photograph number and description	Photograph number and description
Photograph 1: Field density test	Photograph 2: Field density test

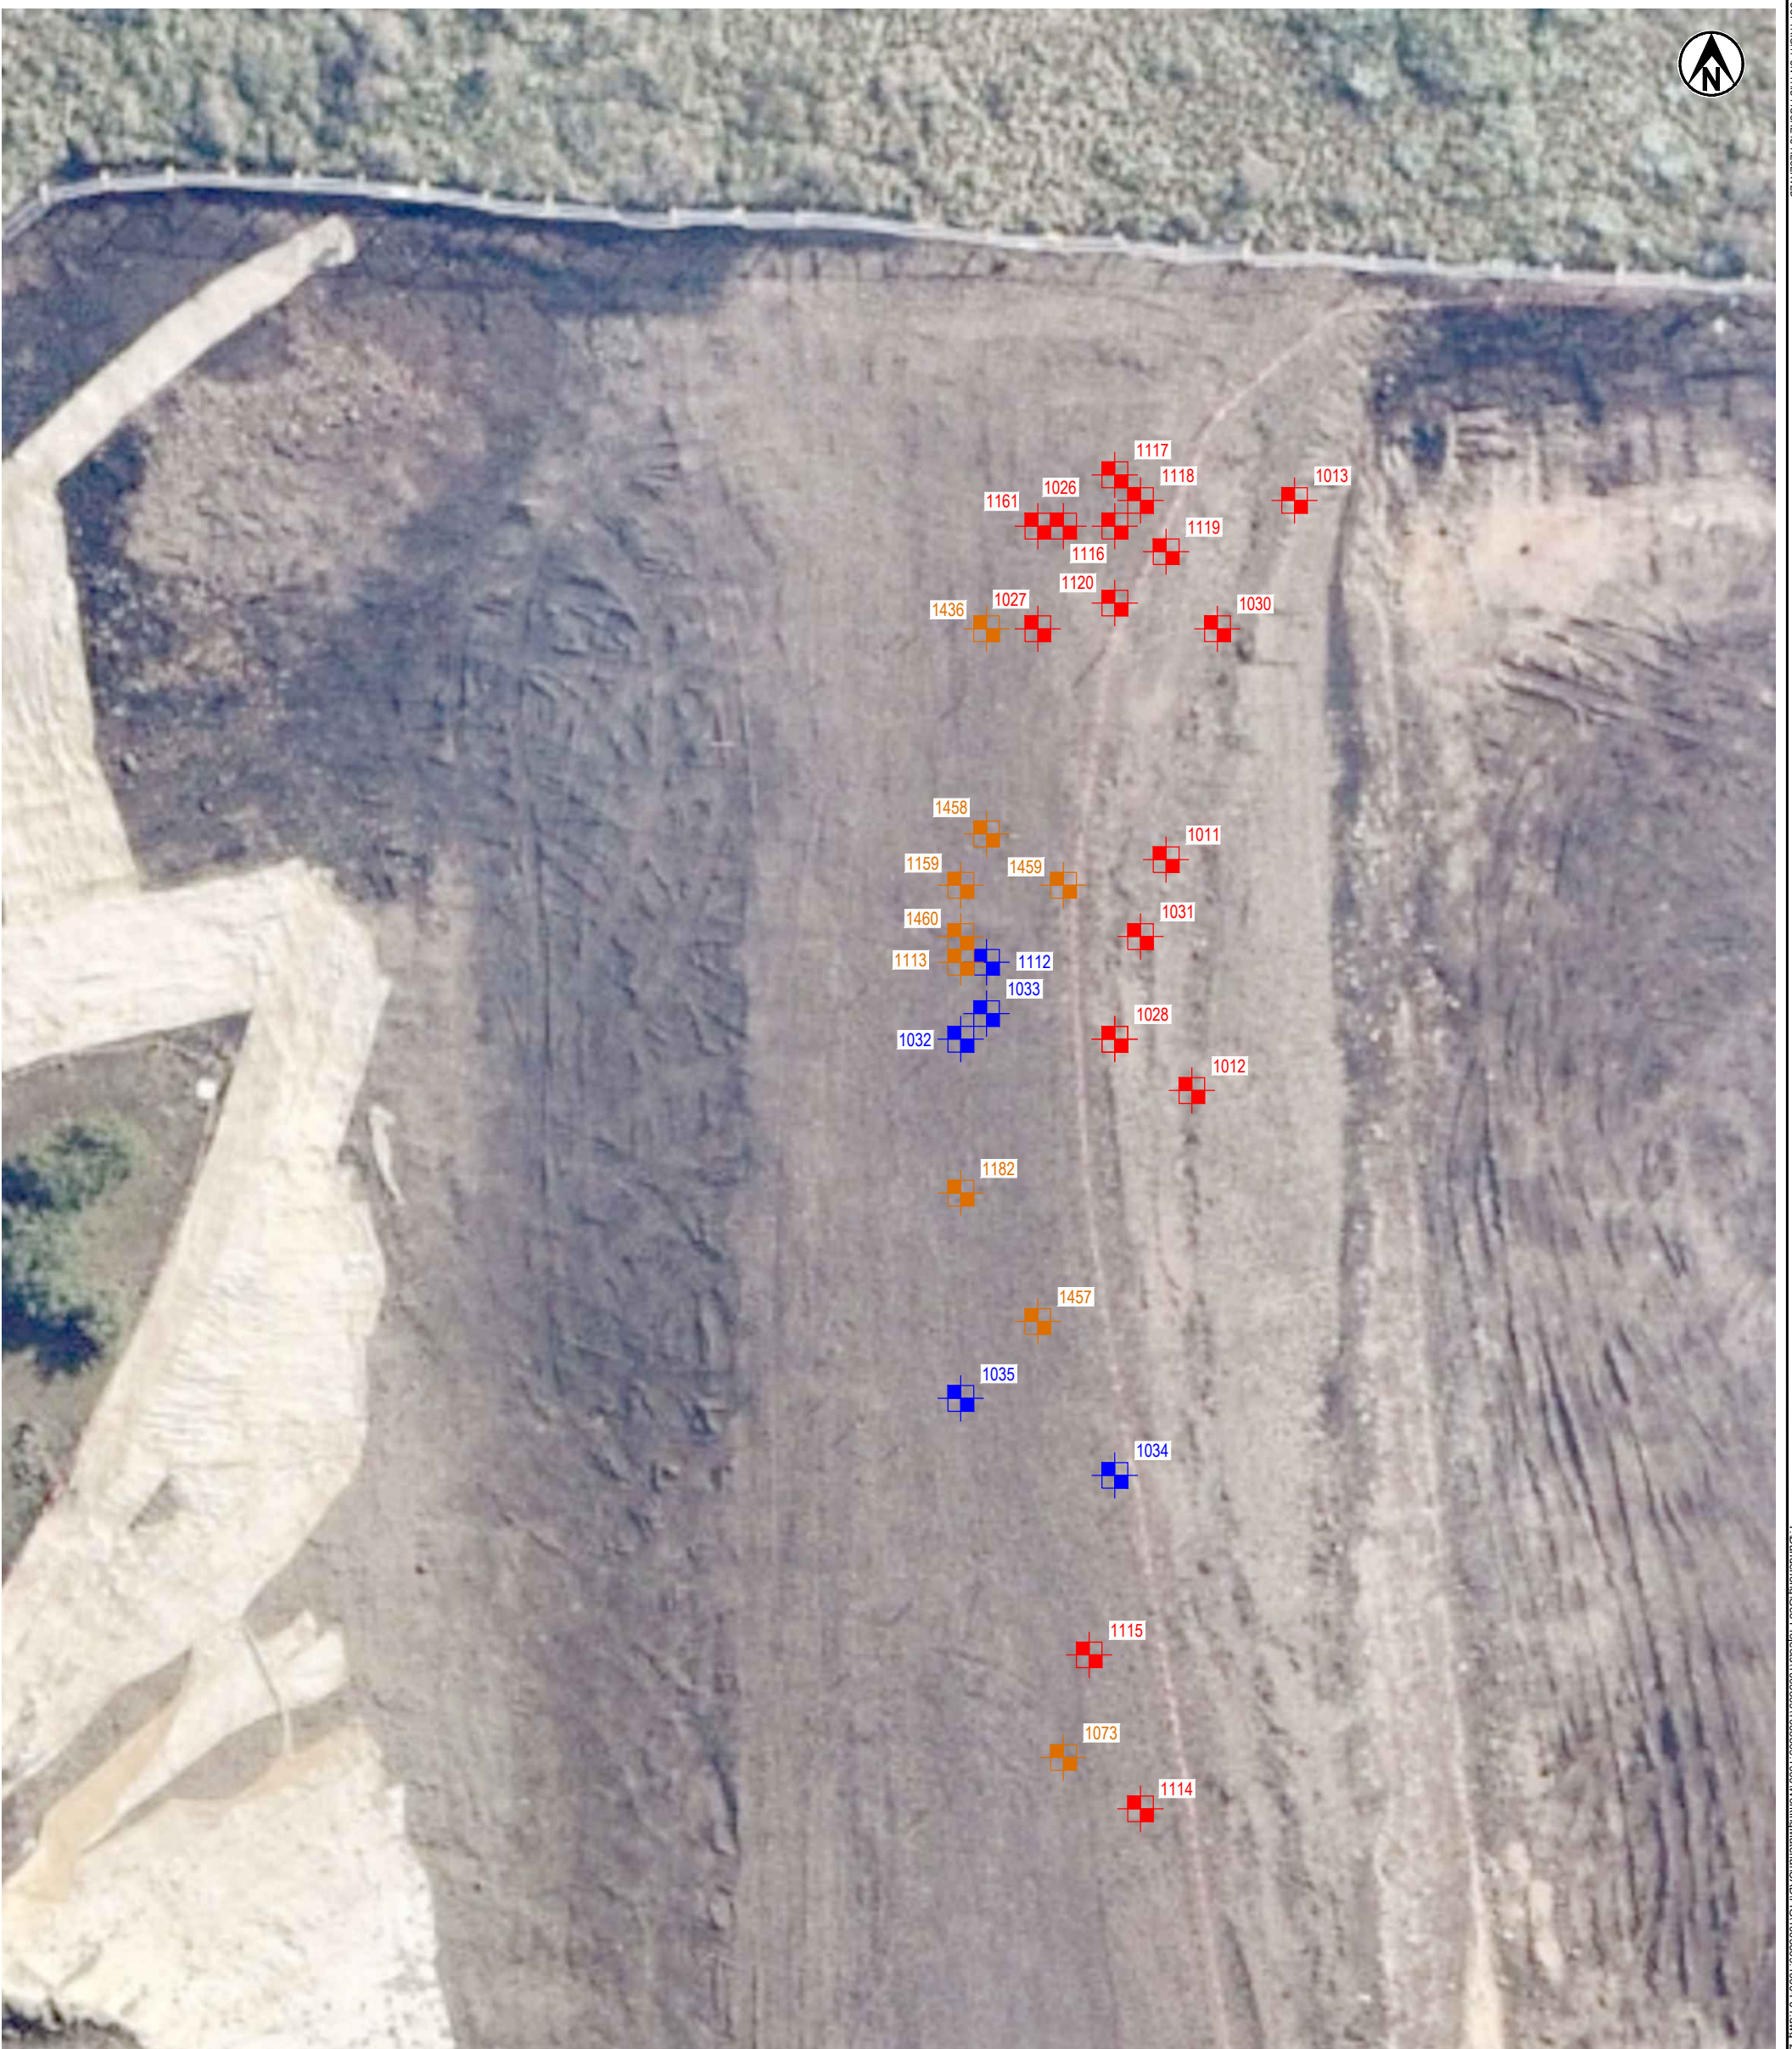
Field density and moisture content testing was undertaken progressively during construction on the compacted fill using a calibrated portable density and moisture gauge in accordance with AS 1289.5.8.1. The HILF rapid compaction test was used for peak converted wet density determinations in accordance with AS 1289.5.7.1. Test locations were recorded using a handheld GPS unit. A site plan showing the field density test locations is provided in **Appendix A**.

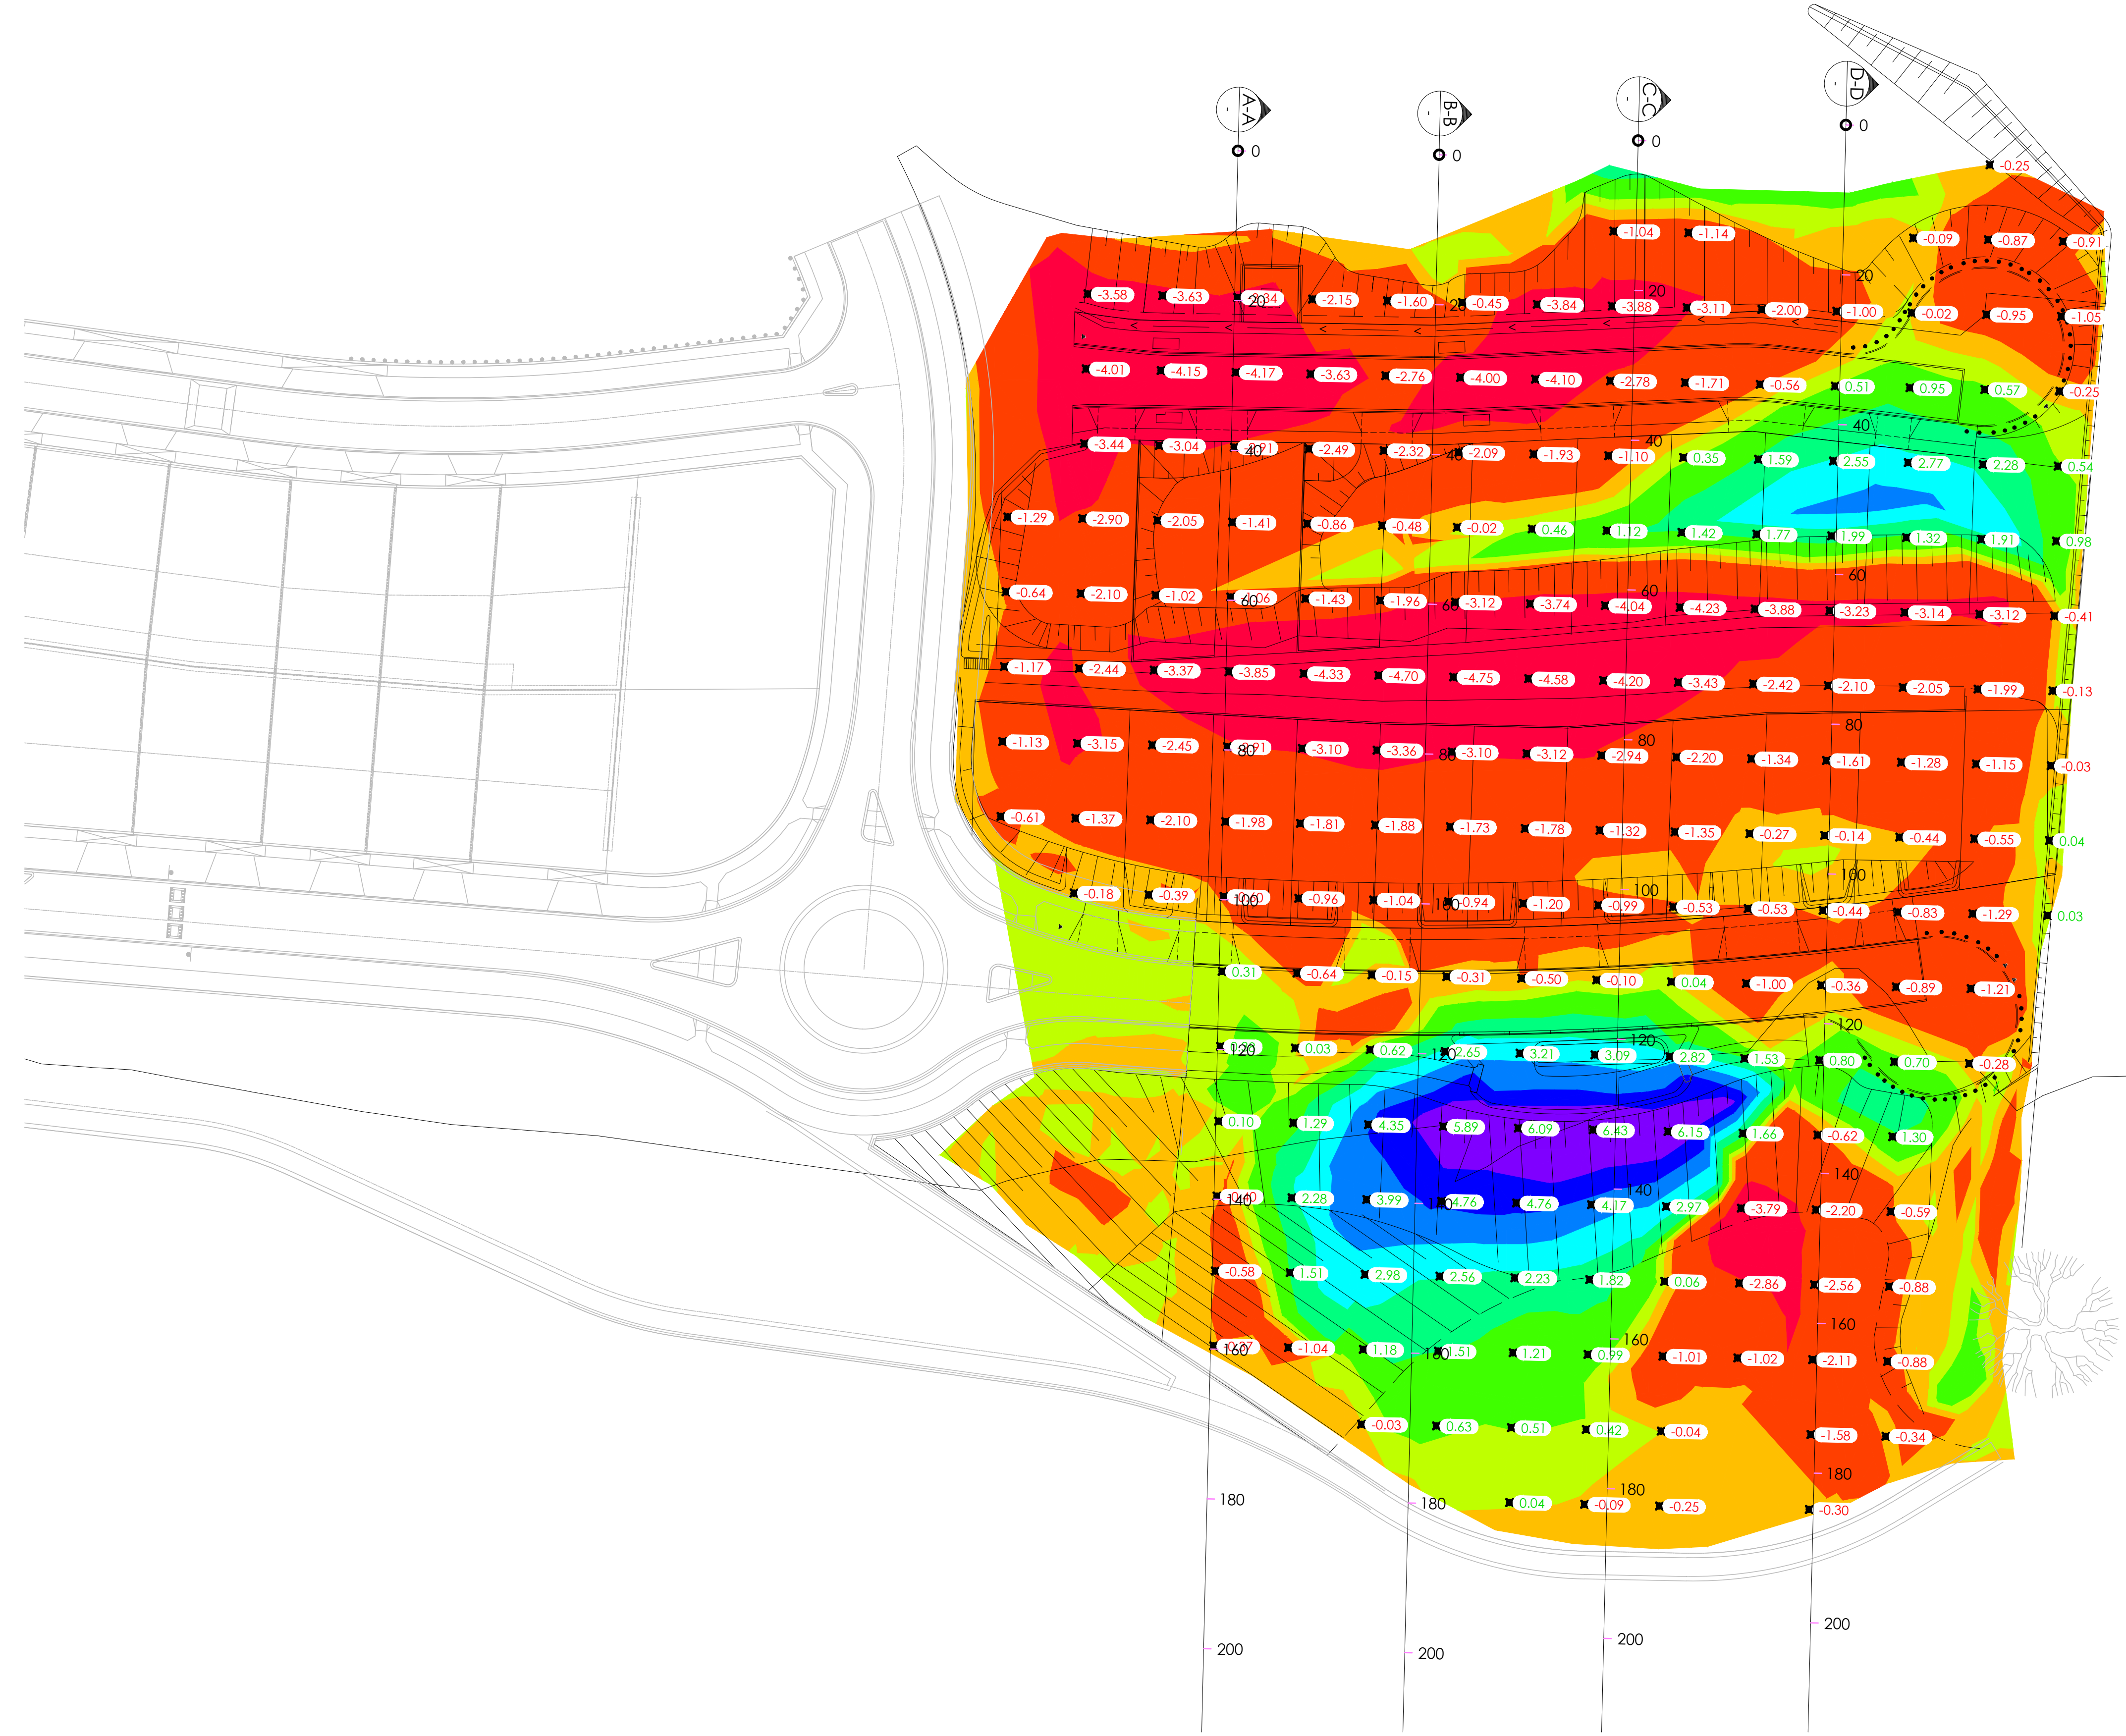
VOLUMES REQUIRED TO ACHIEVE AS-BUILT BULK LEVELS

CJ Arms provided copy of survey drawing in a heat map format, showing the fill thickness placed on the site. The drawing is presented in Appendix D under reference 'Volume Comparison, As – Built Bulk Level VS Existing Ground Level', No 9502, Rev P01, dated 22.10.2022.

- VOLUME OF CUT: 27 358m³
- VOLUME OF REMAINING FILL: 11 540m³
